**Correlation of Rock Quality Designation and Rock Scour  
Around Bridge Piers and Abutments Founded on Rock**

**Research Report KTC-99-57  
KYSPR-94-157**

**Tommy C. Hopkins**  
Chief Research Engineer  
Head of Geotechnology

September 1999

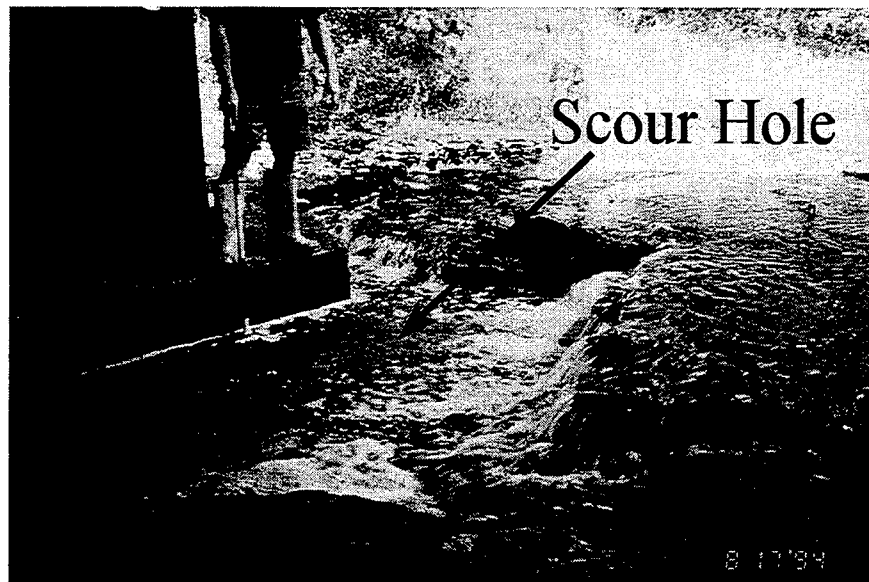
**Figure 1.** A scour hole at a bridge abutment founded on rock, KY Route 1659 bridge over Glenn's Creek in Woodford County, Kentucky.

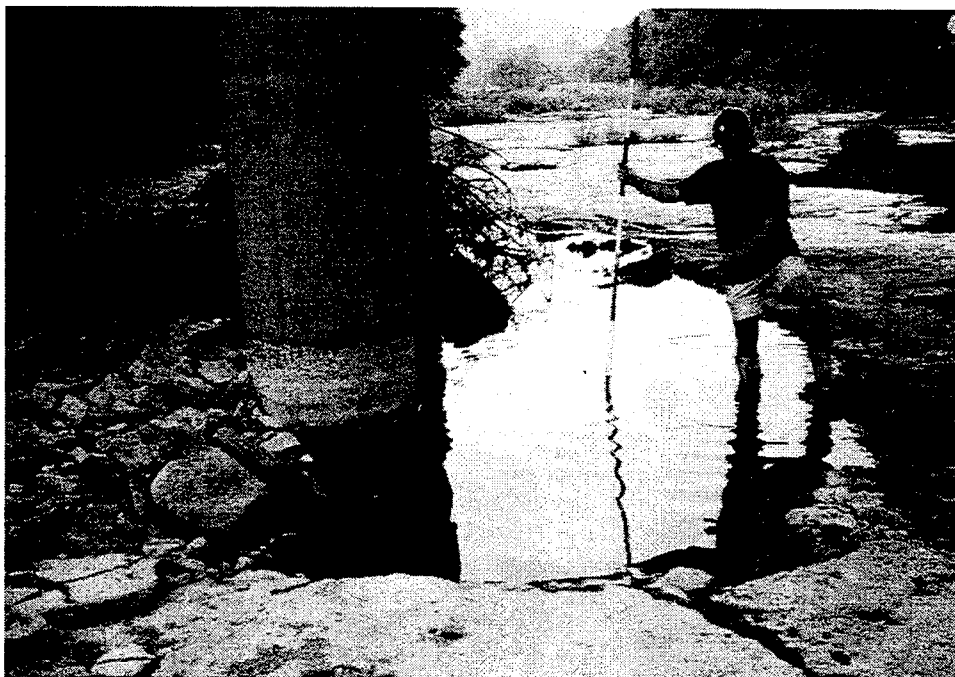
**Figure 4.** Weathered bedrock around a scour hole at a bridge pier, State Route 607 bridge over Cedar Creek in Owen County, Kentucky.

and contraction. Bare rock exposed to the atmosphere is subject to large variations in temperature from day to night. However, frost action or ice wedging is much more effective than heat in producing mechanical weathering. Water that has entered cracks, crevices, and pores of a rock mass usually starts to freeze at the upper surface, where it is in contact with the cooling air. As it passes from the liquid to solid state, water expands. In time, the water below is confined by an ice plug at the surface. Then, as the freezing continues, trapped water expands, and large pressures are exerted outward that can be great enough to dislodge fragments at the rock's surface. The frequency of frost action depends on the climate and the amount of rock surface exposed to the atmosphere. Dislodged fragments of mechanically weathered rock are angular in shape-- the size depends on the type of rock. An example of a weathered bedrock around a scour hole is shown in Figure 4.

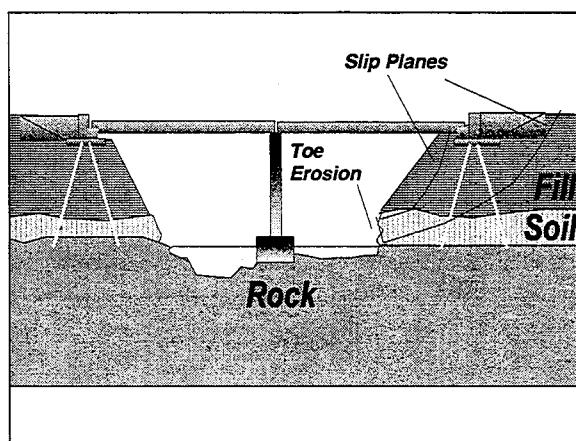
**Figure 9.** Unstable bridge approach embankment created by toe erosion, or scour.

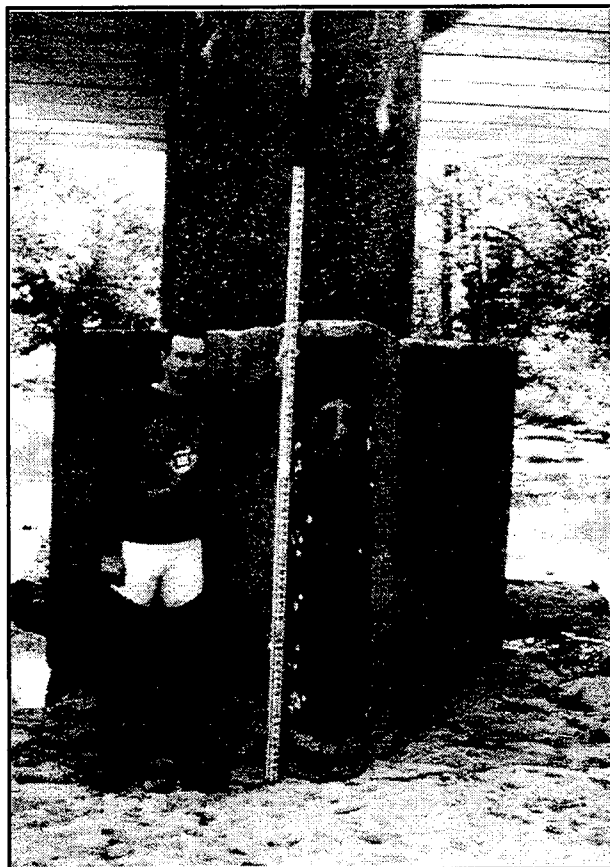
Figure 24. Close-up view of local scour showing

these Figures, the proximity of the apparent rock scour is adjacent to the footer. Consequently, the proximity condition is assigned a value of 100 points. Close examination of the scour hole depth,  $d_s$ , Figure 24, reveals that the bottom of the footer is exposed. This condition is given 100 points. The scour hole depth,  $d_s$ , extends several centimeters below the bottom of the footer. A value of 100 points is assigned to this condition. As shown in Figures 25 and 26, the erosion has penetrated beneath the footer more than 6 inches at several points along the length of the footer. This condition is given a value of 100 points. Finally, the average annual daily traffic is 210 vehicles per day. Because this value is below 400, Table 1, this condition is given a value of above 2 points. The total score for this site is 402 points. As shown in Table 4, a score of 402 corresponds to a code of 2 or 3 of the FHWA Guide -- that is the scour is below the spread footing and countermeasures should be considered.

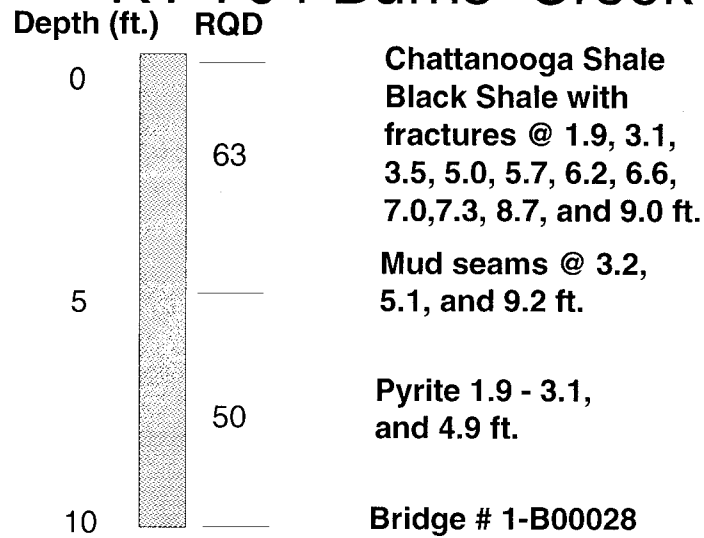
# Adair County KY 704 Burns Creek

Constructed 1952  
Scour Rating = 106  
Small (1 in.) Penetration Scour at  
Corner of Pier Footer  
2 in. Scour Below Footer

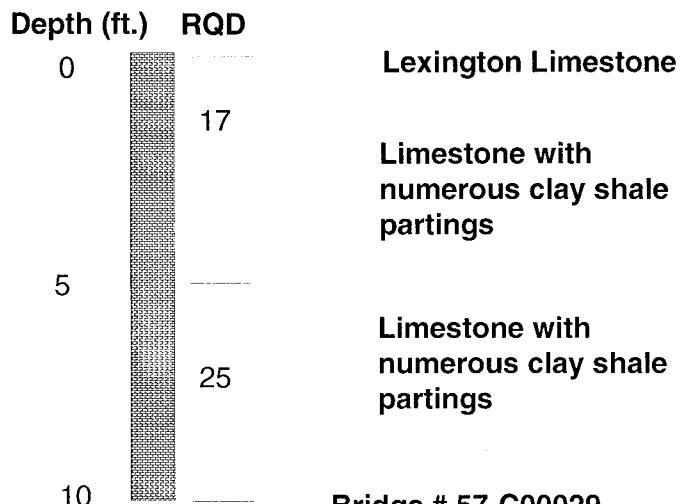
# Jessamine County Elm Fork Road Hickman Creek

**Built 1987?**  
**Deck Only 1987?**  
**Scour Rating = 377**

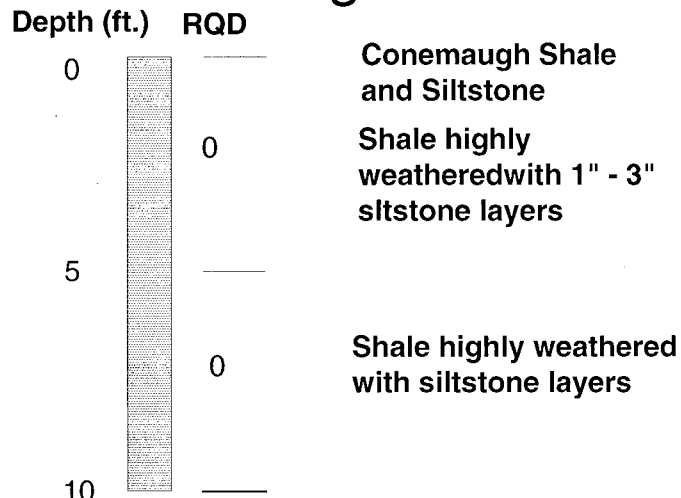
## KY 707 Long Branch Creek

**Bridge # 64-B00035**  
**Constructed 1930 - 1933?**  
**Scour Rating = 401**  
**5 Ft. Penetration Scour**  
**3 Ft. Scour Below Footer**
